Community Site Walk with Landscaping/Grounds Committee on Thursday, April 14, 2016 – Report Completed 5/5/2016

Purpose: The purpose of the inspection was to identify items/infrastructure that need to be repaired or replaced before we, as homeowners, take control of our community. Due to seasonal constraints, the inspection of bushes/shrubs/trees was excluded and will be scheduled for mid-May.

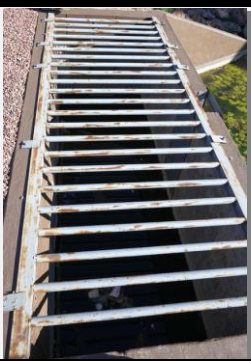
Detention Pond	Metal grate at the end of the pond and is rusting	Classic - Paint to blend with surrounding landscaping material(s)
2.

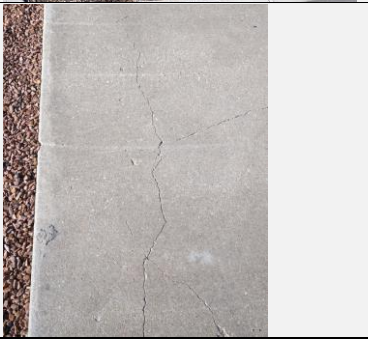
Photo illustrations displaying concrete issues: cracking, broken, and damaged from various utility vehicles	Classic
9.

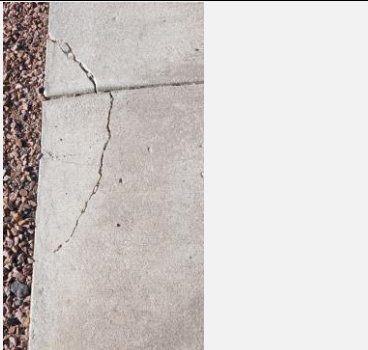
Photo illustrations displaying concrete issues: cracking, broken, and damaged from various utility vehicles	Classic
10.

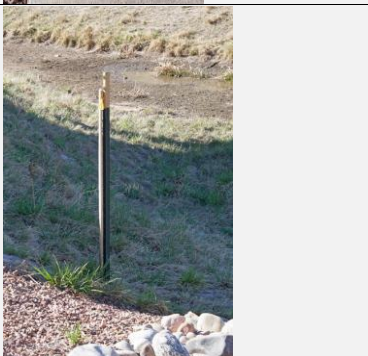
Property line markers – Retention/Detention Pond	Classic to remove
11.

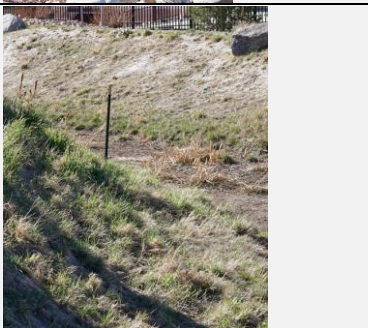
Property line markers – Retention/Detention Pond	Classic to remove

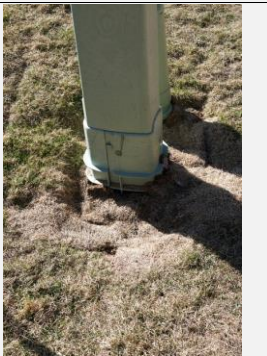
Behind 8414 Castleford Grove and 8419 Glen Carriage Grove	Utility box leaning / landscaping has sunk	Straighten / build up area around utility box / re-sod is necessary

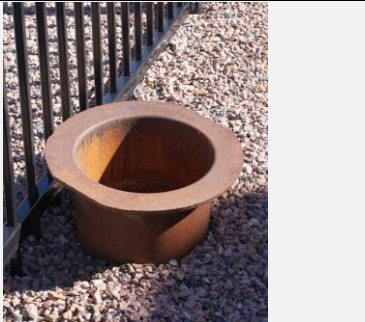
8484 Castleford Grove – Next to fence	This was marked/requested for removal last year	Classic - Remove
24.  	8484 Castleford Grove	Water is seeping into this area and leaching out between the retaining wall	Classic

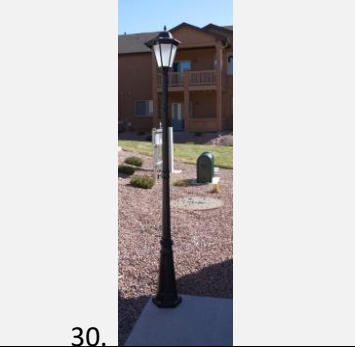
Solar light next to mail kiosk	This is to be moved to a sidewalk location
31.

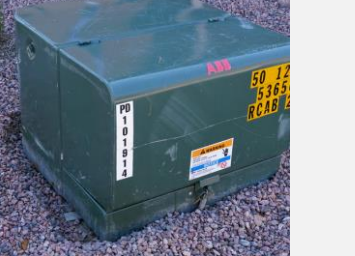
8471 Castleford Grove	Utility box has been moved/shifted

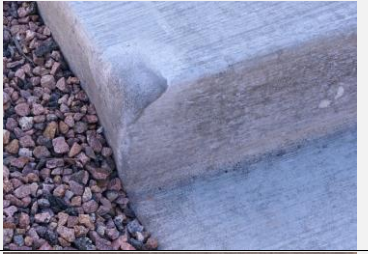
8470 Castleford Grove	Patched broken off corner of sidewalk	Finish off to match more closely
34.

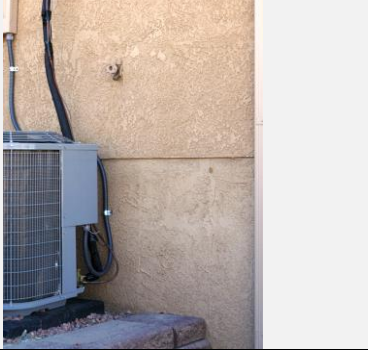
8489 London Carriage Grove	Inconvenient water spigot	This is an owner/Classic request
37.

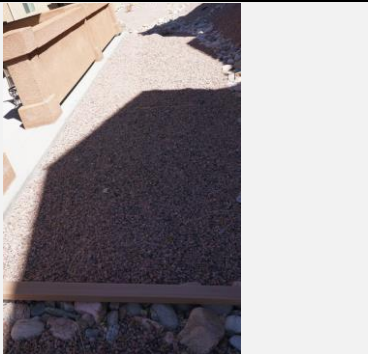
8443 Castleford Grove – Behind privacy wall	No landscaping evident; other than landscaping rock over fabric	Classic

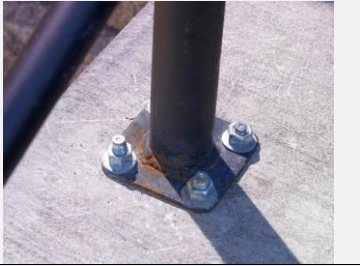
Photo illustration showing rust on many of the railing posts	Two sets of railings in community	Check all and repaint/paint with Rust-Oleum or equivalent to preserve the railing from further rusting

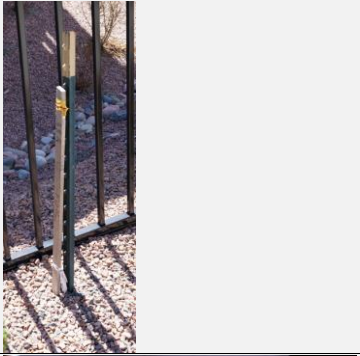
2101 London Carriage Grove	Survey pole to be removed	Classic
48.
